Serpentinite from the Yazagyo Dam site and its related to that Foundation Problem, Kalay Township, Sagaing Region, Myanmar

Aung Myo Zaw⁽¹⁾, Thiha⁽²⁾, Kyi Kyi Maw⁽³⁾

⁽¹⁾⁽²⁾⁽³⁾Dagon University, Department of Geology, Myanmar

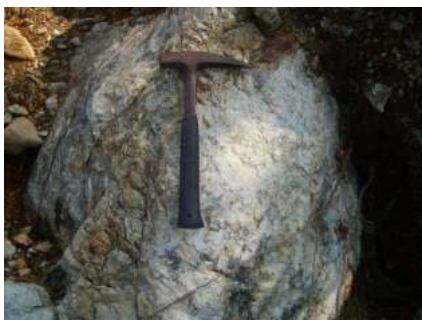
Fig 3. Massive type of Serpentine, at the power house site, (G.P.S loc- 23° 32' 28"N, 94° 05' 06"E), Facing-East

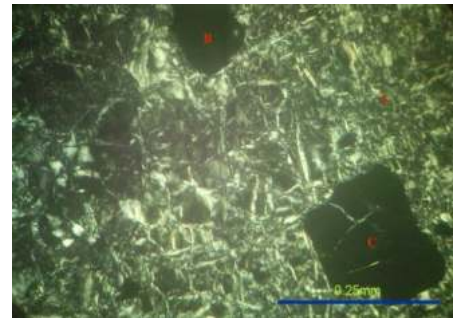
Fig 5. Chromite (C) grain shown in opaque and replaced by serpentine along the cracks, A is Antigorite, B is Bastite (G.P.S loc- 23° 31' 28"N, 94° 05' 18"E), between XN

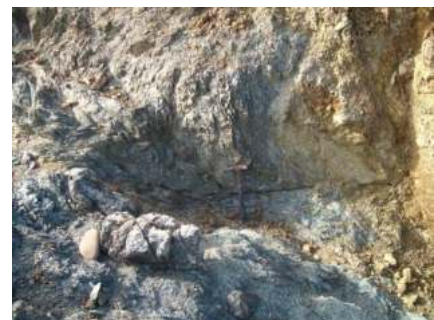
Fig 6. Shear type of serpentine, northern flank of Talone Hill, (G.P.S loc- 23° 31' 49"N, 94° 05' 18"E), Facing-SW

characterized by its smooth shiny surfaces and variations in shades range from dusty yellow-green through grayish-green to pale green or yellow-green. In the study area, along the northern flanks of Talone Hill (Fig-6) and right banching wall of spillway construction are well exposed in this types of serpentine. In microspocic study, this type of serpentine is shown in hourglass texture with interlocking (Fig-7) and interpenetrating. The predominant minerals are antigorite and Chrysotile. The antigorite has shown hourglass texture with 60-75%. However, they are never found alone and are usually found in combination with interpenetrating or interlocking textures. Chrysotiles are seen as small cross veins with 25-35% (Fig-8). Some are cutting the other minerals. Magnetite is very fine grained with sub-parallel and disseminated grains in the hourglass texture. Mostly these are found as sub-rounded to sub-rectangular shape.

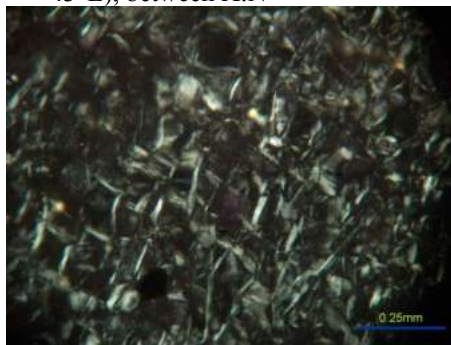
Fig 13. Relic olivine grains in the mesh structure. Sample no-15, (G.P.S loc- 22° 31' 34.3"N, 94° 05' 43"E), between X.N

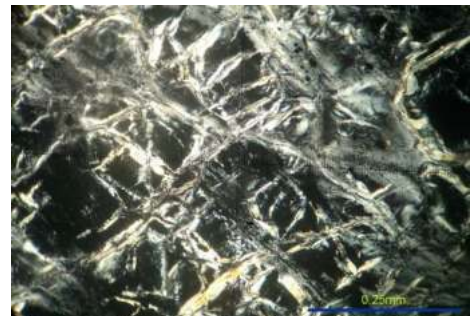
Fig 15. Mesh texture (mesh rimmed, mesh centred). Sample no-J, (G.P.S loc- 23° 31' 46"N, 94° 05' 21"E), between X.N

Pseudomorphic texture like mesh texture (mesh rimmed, mesh centred) (Fig-15) and hourglass structure are quite common in bastite and antigorite of this zone (Fig-16). Non-Pseudomorphic textures of interlocking and slip-fibre veins are also observed (Fig-18). These are exposed at or near the saddle Dam II. Mesh textures show variants in outline, square, equilateral or even triangular (Fig-15). Such textures are sometimes found at the rims or otherwise centred. Frequently relic olivine is found as mesh centres or concentrated small disseminated grains, and sometime large amounts with granular form. Magnetite is found as large amount.

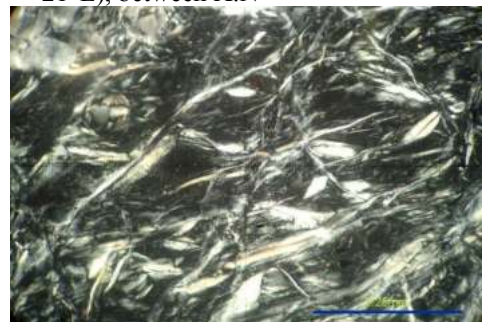
Fig 16. Hourglass structure and thorn shaped antigorite in the serpentinite. Sample no- D, (G.P.S loc- 23° 32' 25"N, 94° 05' 18"E), between X.N

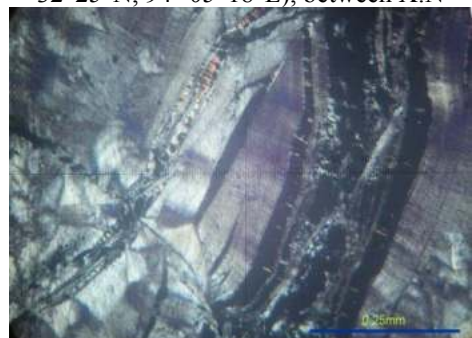
Fig 17. Slip-fiber vein in the serpentinite. Sample no-G, (G.P.S loc- 23° 31' 48"N, 94° 05' 19"E), between X.N

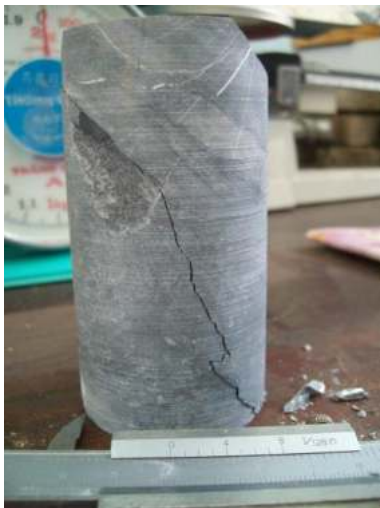
Fig 18. Failure of serpentine core sample, after the UCS testing.

The uniaxial compression strength test was carried out on four serpentine rock core samples. The test results showed the uniaxial compressive strength has 14 MPa, 14.2 MPa, 15.3 MPa and 14.8 MPa respectively. The first two are resulted of the partially serpentinized samples and the others are completely serpentinized samples. The mode of failure is shown in (Fig-18). This result reveals that the strength of serpentine rocks is very low strength, according to Deere and Miller's intact rock strength classification. The strength of these serpentine rocks are not really precise with laboratory testing after, Cappell and Maurice (1980), so these rock are should be measured with some in-situ methods such as plate bearing test, groundmass and block ratio, and Elastometer test etc.

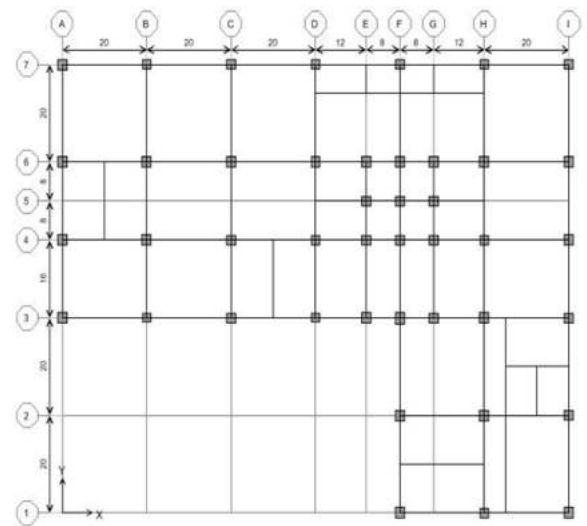
Fig 3. Line Plan of Proposed Structure

Line plan of proposed damped structure are shown in Figure 3.

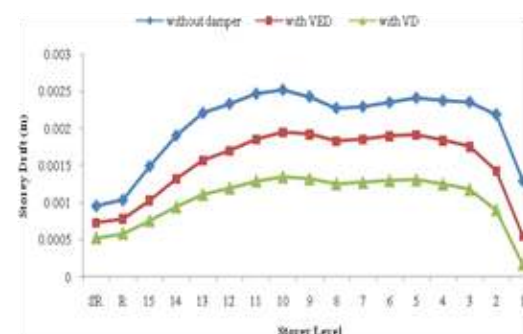
Fig 4. Comparison of storey drift in X direction

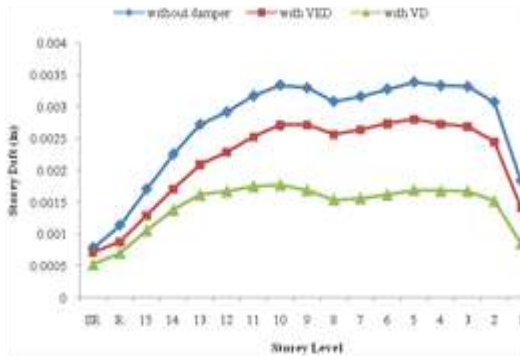
Fig. 5 Comparison of storey drift in Y direction

Storey	Storey Drifts in Y direction		
	Without damper	With Viscoelastic damper (VED)	With Viscous damper (VD)
SR	0.000784	0.00071	0.000521
R	0.00114	0.000873	0.000702
15	0.001705	0.001286	0.001059
14	0.002253	0.001706	0.001379
13	0.002719	0.00209	0.001619
12	0.002917	0.002284	0.001675
11	0.00317	0.002527	0.001753
10	0.00334	0.002711	0.001777
9	0.003295	0.002718	0.001692
8	0.003082	0.002569	0.001541
7	0.00316	0.002644	0.001563
6	0.003276	0.002734	0.001623
5	0.003385	0.002803	0.001693
4	0.003331	0.002732	0.001682
3	0.003316	0.00269	0.001678
2	0.003075	0.002452	0.001522
1	0.001835	0.001419	0.000856

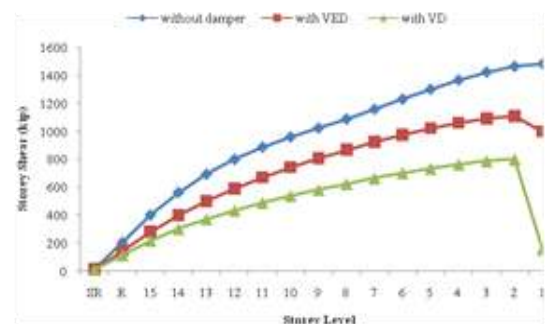
Fig 6. Comparison of storey shear in X direction

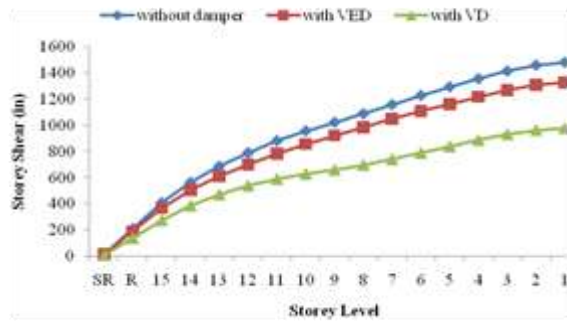
Fig 7. Comparison of storey shear in Y direction

Storey	Storey Shear in Y Direction		
	<i>Without damper</i>	<i>With Viscoelastic damper (VED)</i>	<i>With Viscous damper (VD)</i>
SR	15.9	14.55	10.01
R	213.11	189.94	141.15
15	410.76	366.77	277.47
14	565.82	504.31	388.19
13	687.98	610.73	474.28
12	791.73	701.02	540.8
11	882.36	783.15	592.06
10	958.08	856.3	630.82
9	1023.53	921.55	663.49
8	1089.57	984.48	699.14
7	1159.49	1046.54	742.12
6	1228.96	1105.61	790.56
5	1294.63	1161.26	840.72
4	1357.05	1215.3	889.59
3	1414.87	1266.36	933.25
2	1459.26	1305.97	965.09
1	1481.86	1326.41	980.84

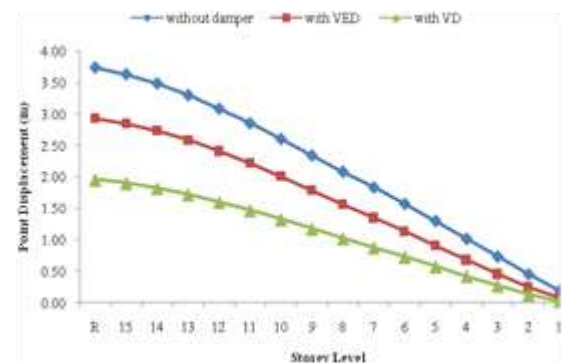
Fig 8. Comparison of point displacement in X direction

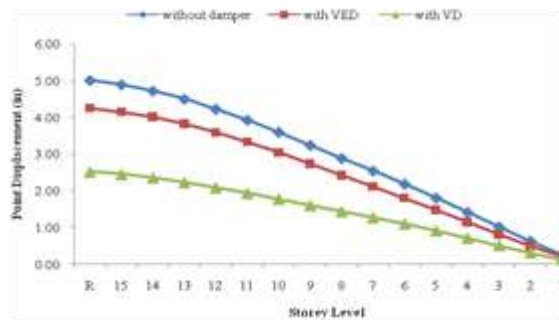
Fig 9. Comparison of point displacement in Y direction

Storey	Point Displacement Y Direction		
	<i>Without damper</i>	<i>With Viscoelastic damper (VED)</i>	<i>With Viscous damper (VD)</i>
SR	5.01	4.2505	2.5155
R	4.90	4.1534	2.4488
15	4.73	4.0113	2.3527
14	4.50	3.8231	2.2301
13	4.23	3.5908	2.0861
12	3.93	3.3343	1.9348
11	3.60	3.0474	1.7728
10	3.24	2.7363	1.6026
9	2.88	2.4211	1.4324
8	2.54	2.12	1.2682
7	2.18	1.8074	1.0937
6	1.80	1.4822	0.9063
5	1.41	1.1474	0.7067
4	1.01	0.8203	0.5061
3	0.62	0.4978	0.3053
2	0.26	0.2036	0.1229
1	5.01	4.2505	2.5155

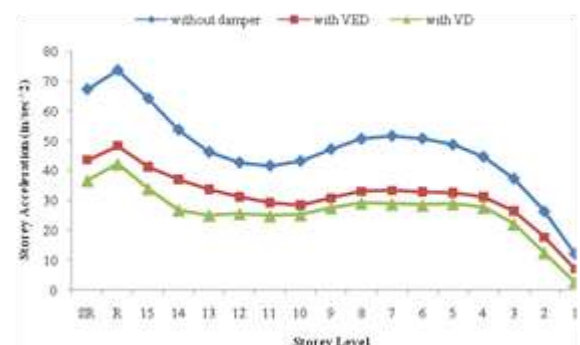
Fig 10. Comparison of storey acceleration in X direction

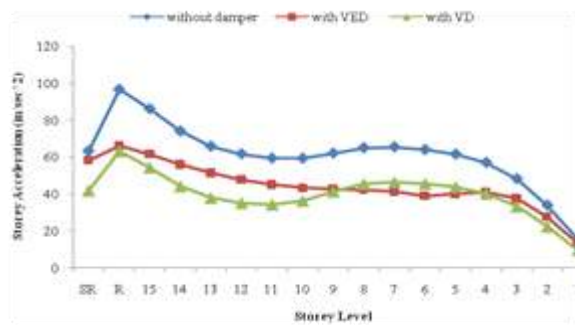
Fig 11. Comparison of storey acceleration in Y direction

Storey	Storey Acceleration in Y Direction		
	Without damper	With Viscoelastic damper (VED)	With Viscous damper (VD)
SR	63.1956	58.3786	41.668
R	96.6319	66.1917	63.0177
15	86.0925	61.5754	54.1371
14	74.0363	56.0722	44.1082
13	65.7581	51.3859	37.7818
12	61.5986	47.8106	35.122
11	59.3041	45.0972	34.2058
10	59.2318	43.3435	36.2311
9	62.0216	42.7391	41.1416
8	64.9958	42.388	45.2759
7	65.3972	41.1484	46.3193
6	63.9245	38.9296	45.4478
5	61.4759	40.0396	43.6585
4	56.9398	41.0674	40.1056
3	48.1382	37.5438	33.2014
2	33.7334	27.6747	22.3299
1	15.4612	13.1578	9.5677

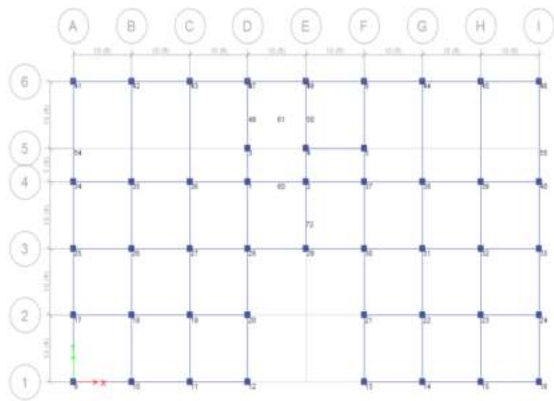
Fig 1. Floor Plan for Proposed Building

Location	: Seismic zone IV
Type of Building	: Eighth-storyed Irregular-shaped RC Building
Type of Occupancy	: Residential
Plan Dimension	: X direction = 80 ft Y direction = 45 ft
Height of Building	: 107 ft
Typical Story Height	: 11 ft
Bottom Story Height	: 11 ft
Depth of Foundation	: 10 ft

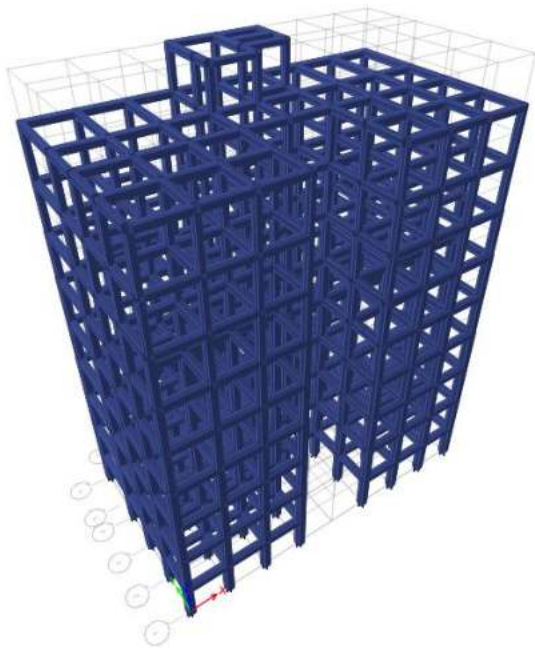
Fig 2. 3D View for Proposed Building

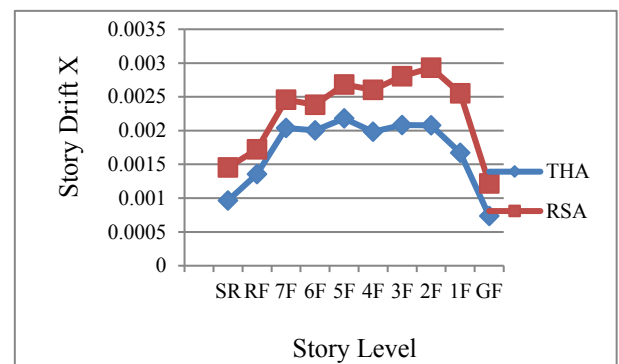
Fig 3. Story Drift X due to EX

The peak value in story drift X and Y due to EX and EY can be resulted at 2F of the proposed building for both RSA and THA. From the above figures, story drifts for RSA are 40.8% and 12.5% more than that for THA. So, the structural results of RSA give more significant seismic response of the proposed building for the dynamic analysis.

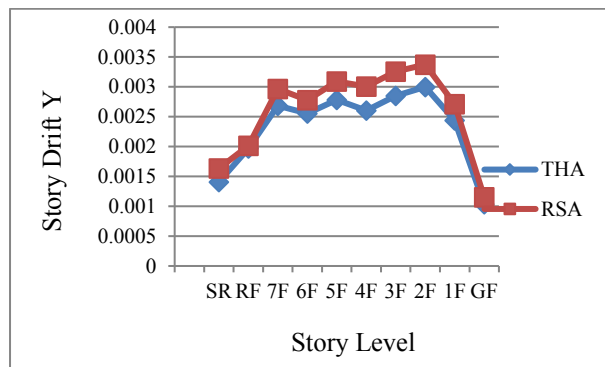
Fig 4. Story Drift Y due to EY

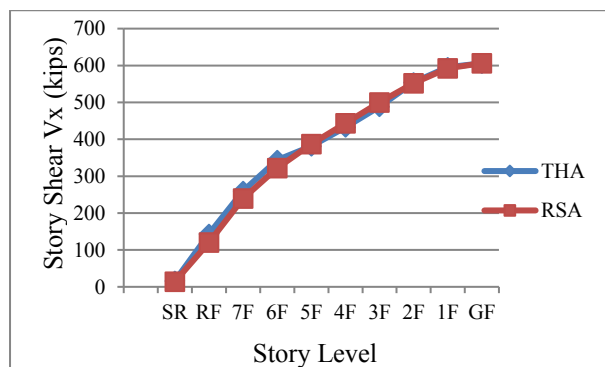
Fig 5. Story Shear Vx due to EX

Figures 5 and 6 describe the comparison of story shears of RSA and THA. The horizontal line presents the story level and the vertical line presents story shears in kips respectively. Story shears of THA are less than 0.05% and 0.03% for X and Y directions at GF than that of RSA.

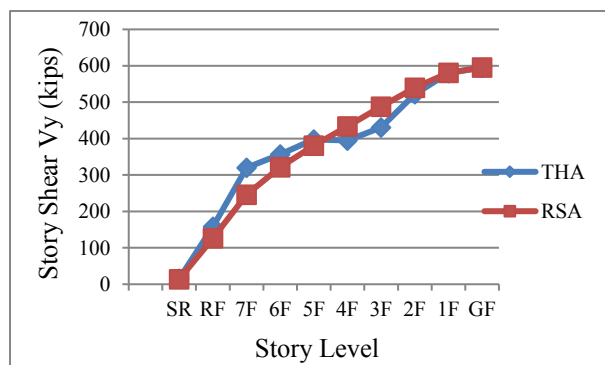
Fig 6. Story Shear Vy due to EY

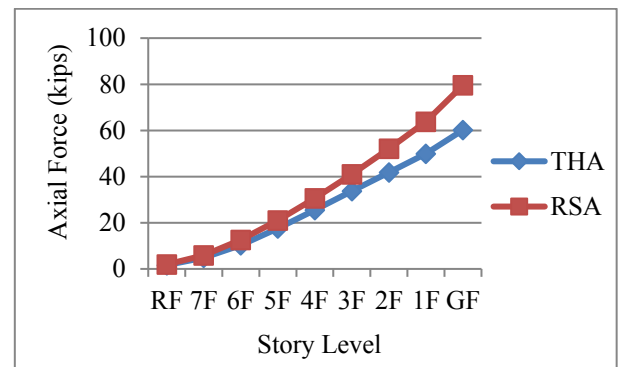
Fig 7. Axial Force due to EX for Corner Column

According to above figures, the gradual increase in axial forces is found in corner and exterior columns for both THA and RSA. It can be seen that more obvious increase in axial force for interior column of RSA than 34.7% that of THA at 1F.

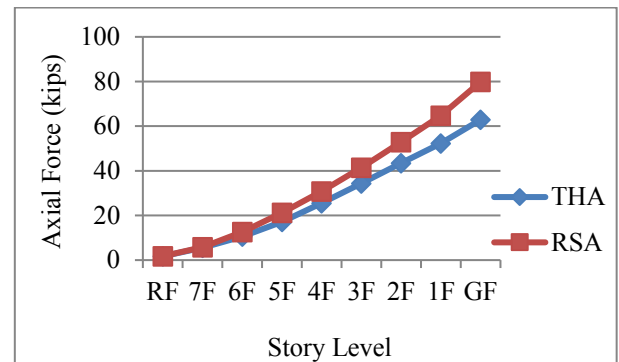
Fig 8. Axial Force due to EX for Exterior Column

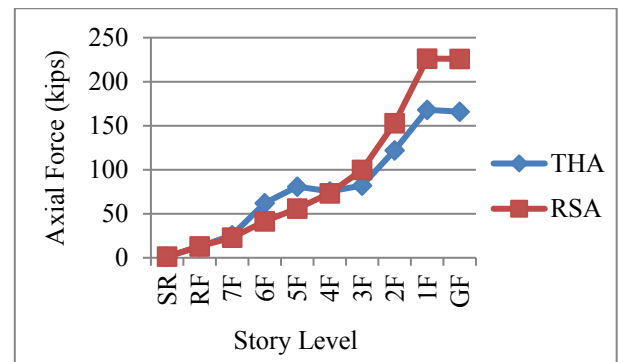
Fig 9. Axial Force due to EX for Interior Column

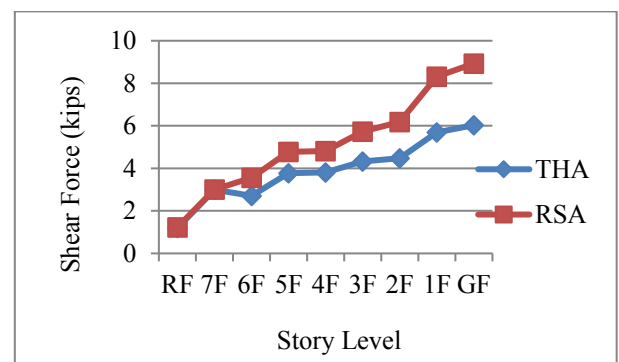
Fig 10. Shear Force due to EX for Corner Column

According to Figures 10 to 12, there is a significantly fluctuate in shear forces of columns at 2F and 6F due to EX. The obvious difference about 51% between RSA and THA can be seen at 2F for the interior column of proposed building.

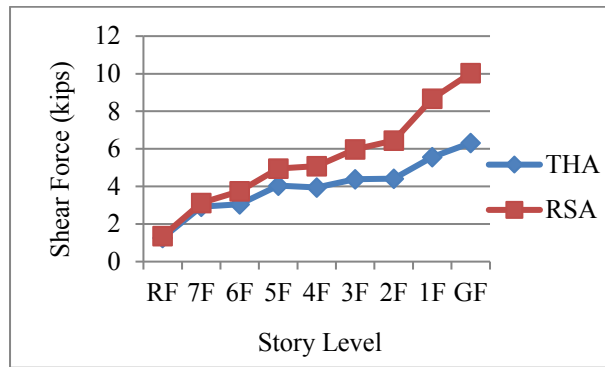
Fig 11. Shear Force due to EX for Exterior Column

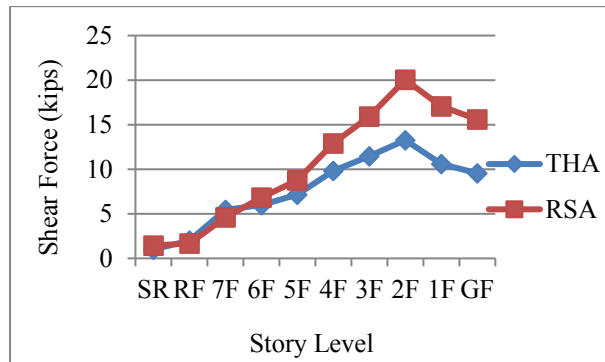
Fig 12. Shear Force due to EX for Interior Column

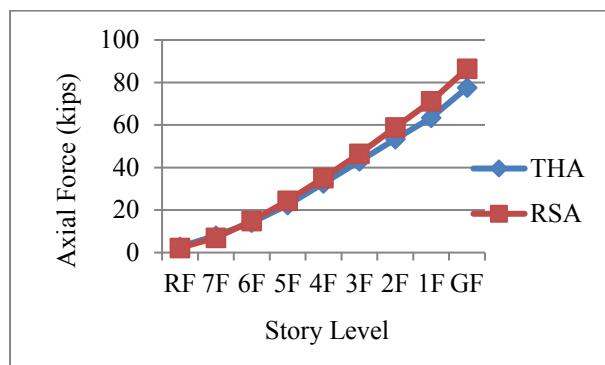
Fig 13. Axial Force due to EY for Corner Column

According to above figures, the significant increase in axial forces is found in corner and exterior columns due to EY for both THA and RSA. It can be observed that more fluctuated change about 47.8% in axial force for interior column of RSA and THA at 5F.

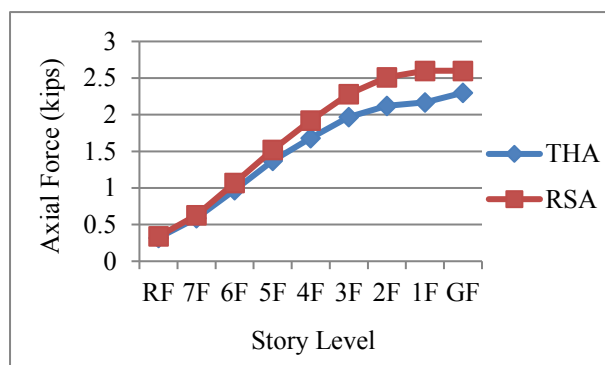
Fig 14. Axial Force due to EY for Exterior Column

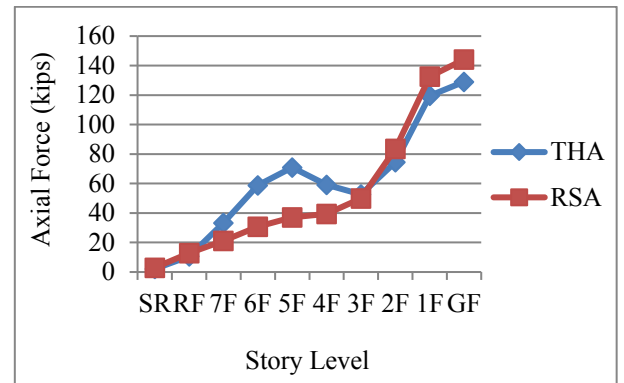
Fig 15. Axial Force due to EY for Interior Column

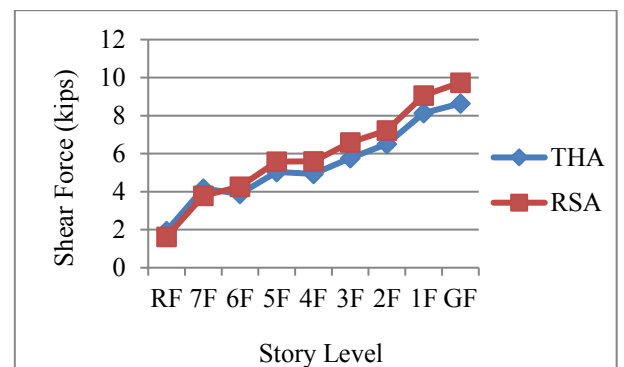
Fig 16. Shear Force due to EY for Corner Column

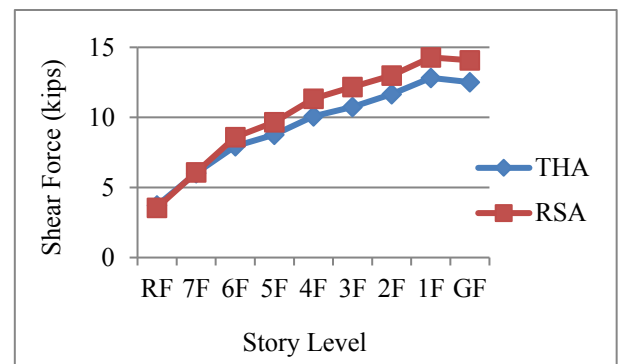
Fig 17. Shear Force due to EY for Exterior Column

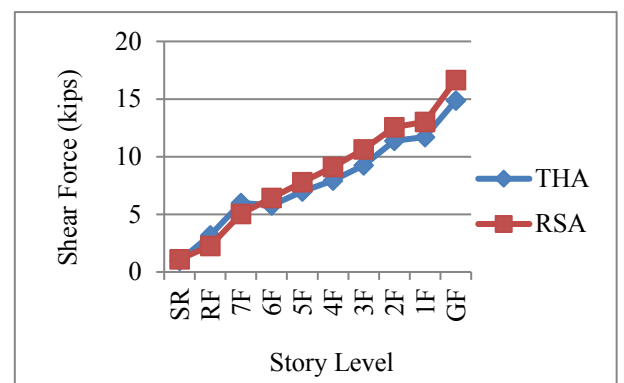
Fig 18. Shear Force due to EY for Interior Column

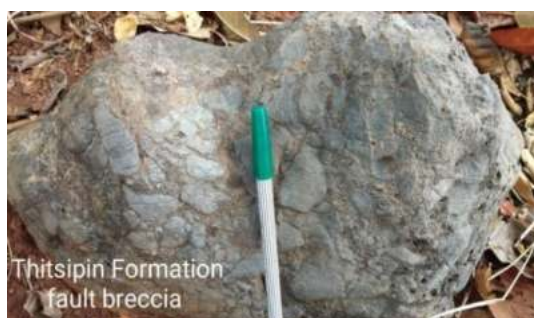
Figure (6) Fault breccia of Thitsipin Formation (Loc: 20°56' 42" N and 96° 38' 46"E, near Htutni(North) village, North-east Facing)

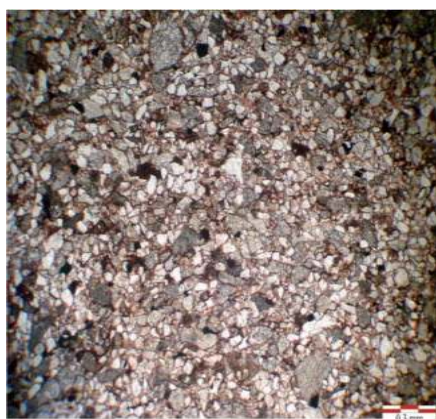
Figure (19) Microphotographic showing the micron to centimicron sized dolomite crystals in Thitsipin Formation. (Under PPL)

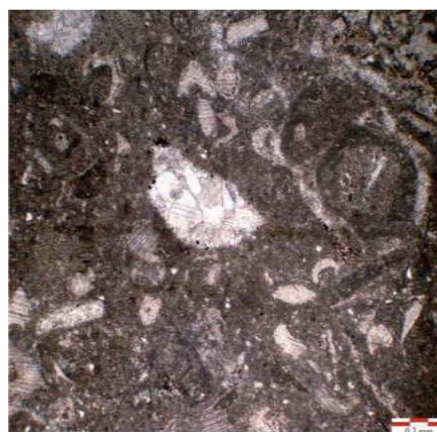
Figure (20) Microphotographic showing the Sparry calcites occur as interparticle and intraparticle void-filling in intrasparite of Thitsipin limestone. (Under PPL)

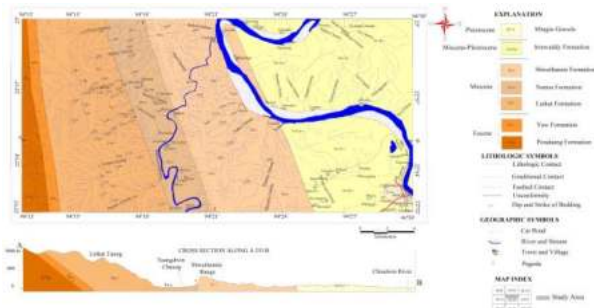
Fig. (4) Geological map of the Theingon area

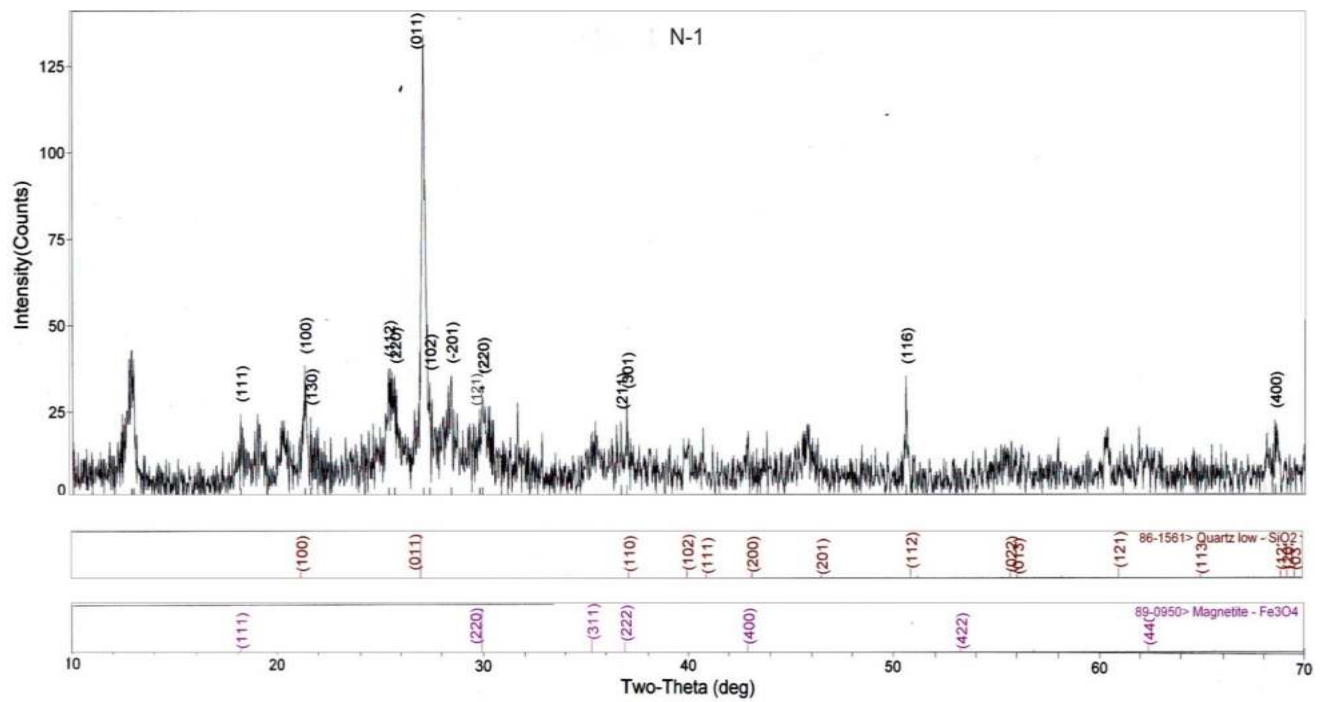
Fig. (5) XRD Spectrum of N-1

From the result of X-ray diffraction (XRD) technique, the soils of the Theingon area soils have a high content of clay minerals. The main types of clay minerals in the study area are chlorite, kaolinite and muscovite and other associated minerals such as quartz, serpentine, hematite, albite, magnetite and pyrolusite are present. Amesite, clinocllore and nimite minerals are the members of chlorite group (Kunze, et al., 1953). Chlorite may be more abundant in clays deposited in brackish and fresh-water environment than in those deposited under open marine conditions (Pettijohn, 1987). Chlorite also develops at depth, and into the zone of incipient metamorphism (Tucker, 1988). Kaolinite is dominant in low latitude area, particularly off major rivers draining regions of tropical weathering, and illite and chlorite are more common in higher latitude marine muds (Pellant, 1992). The illite (or the clay-mica) group is basically a hydrated microscopic muscovite. Illite is the most abundant and consists of a family of fine-grained micaceous minerals (Fairbridge, 1987).

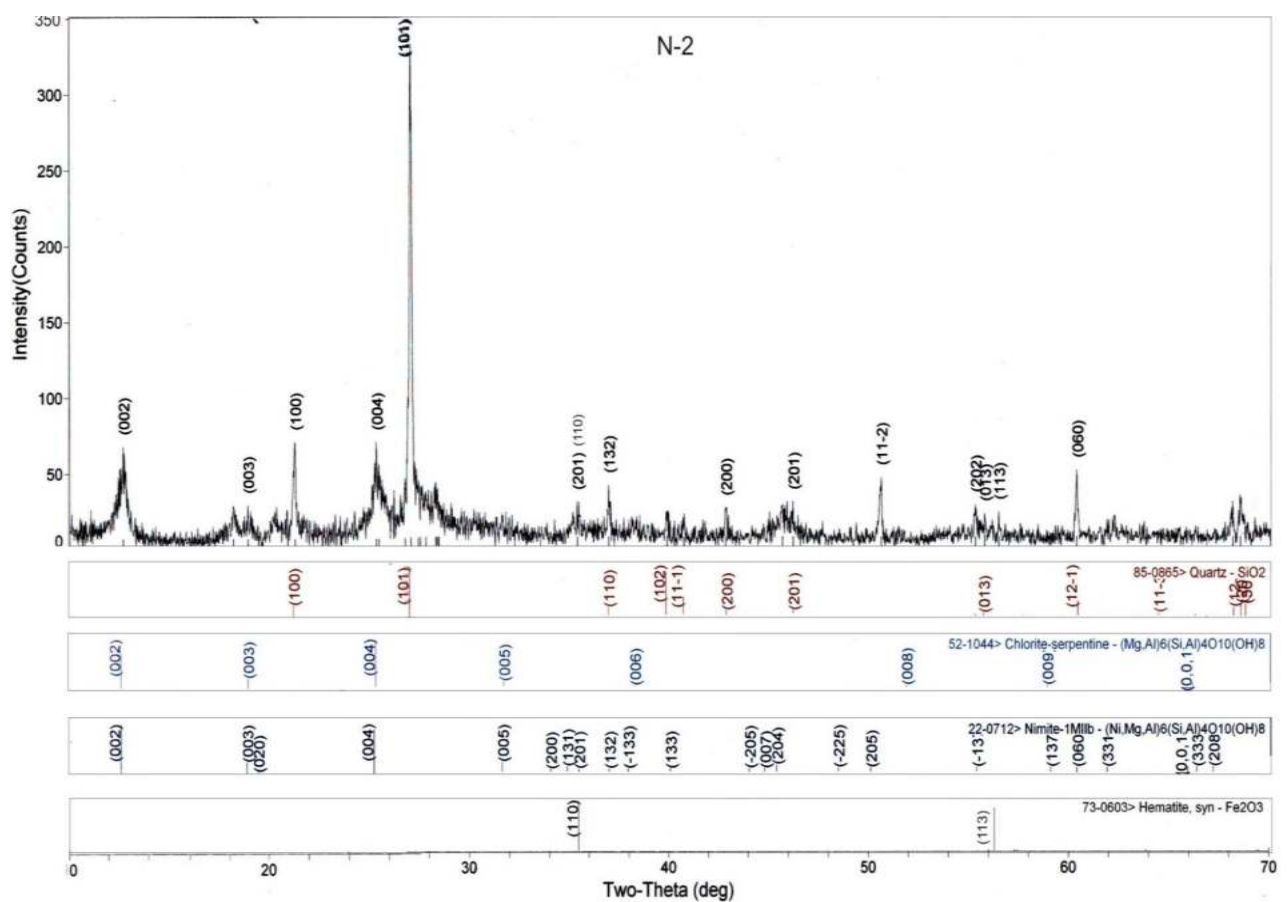
Fig. (6) XRD Spectrum of N-2

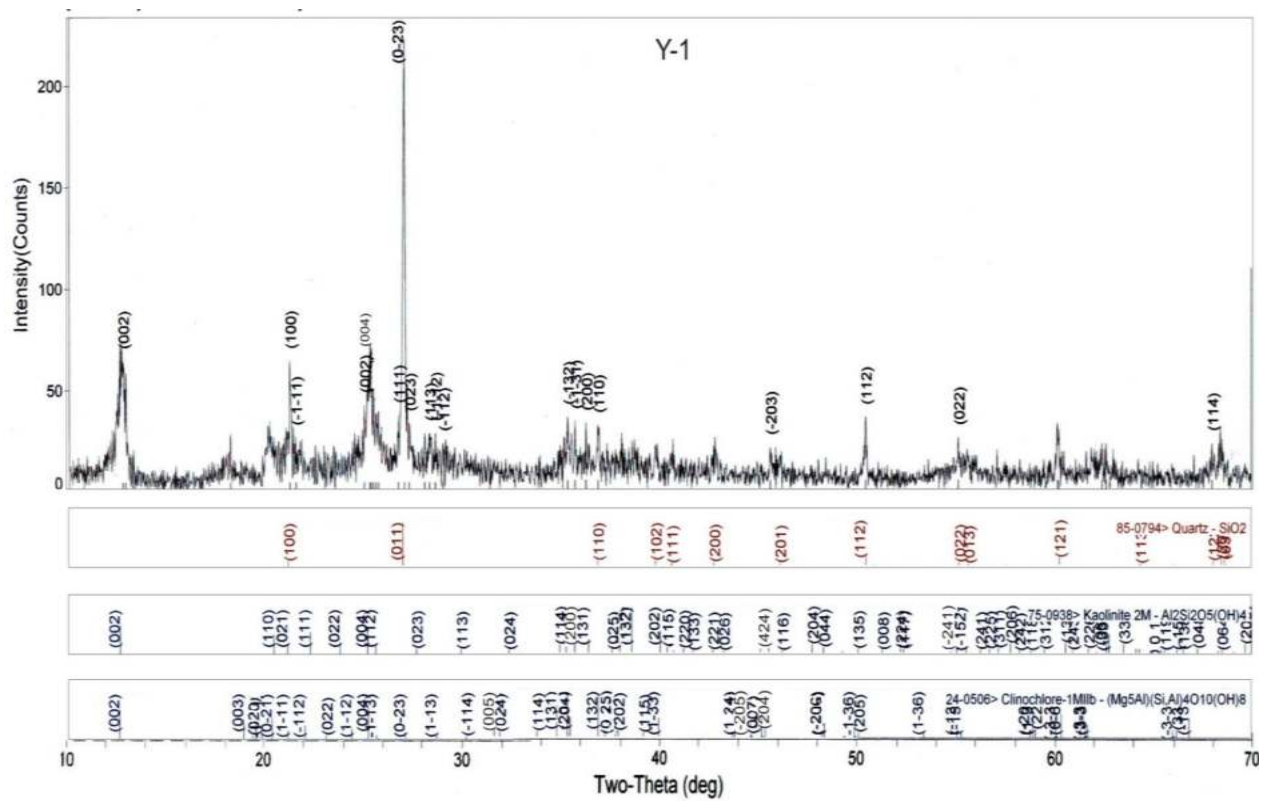
Fig. (11) XRD Spectrum of Y-1

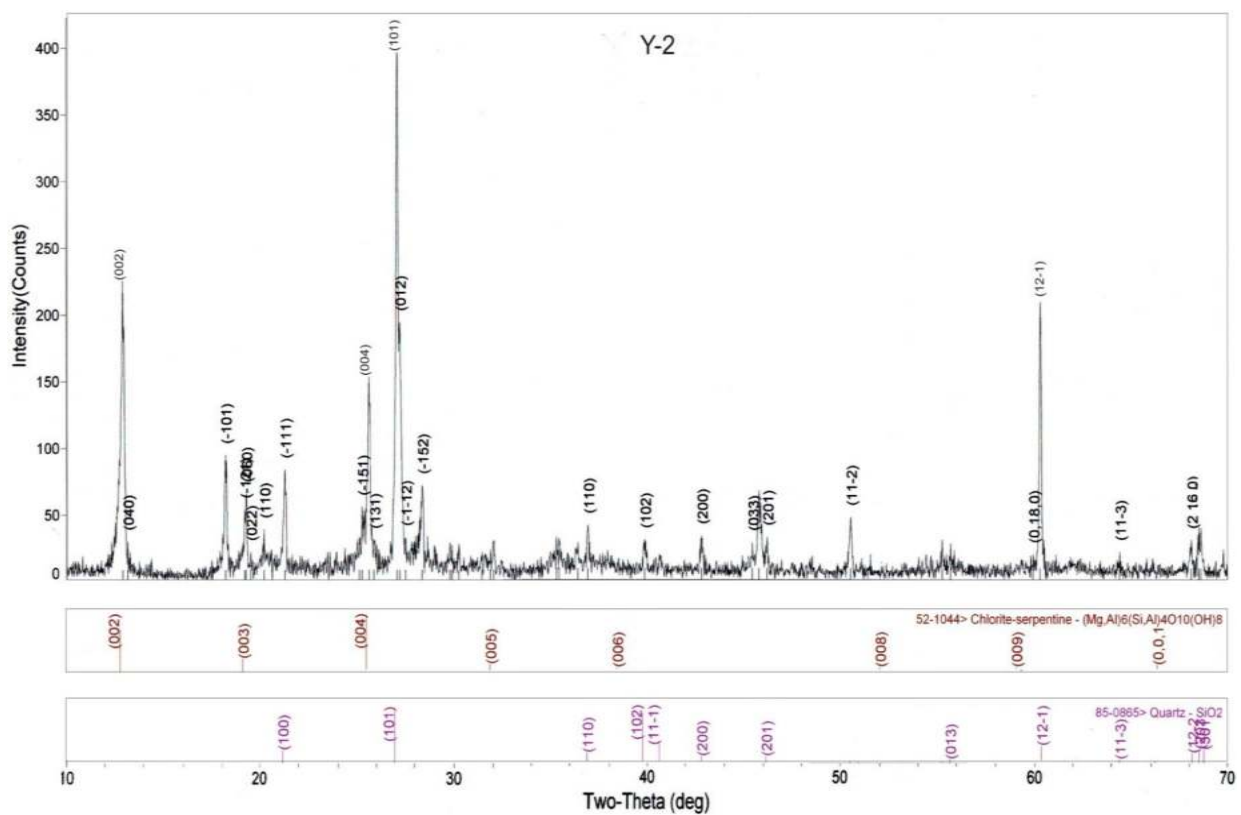
Fig. (12) XRD Spectrum of Y-2

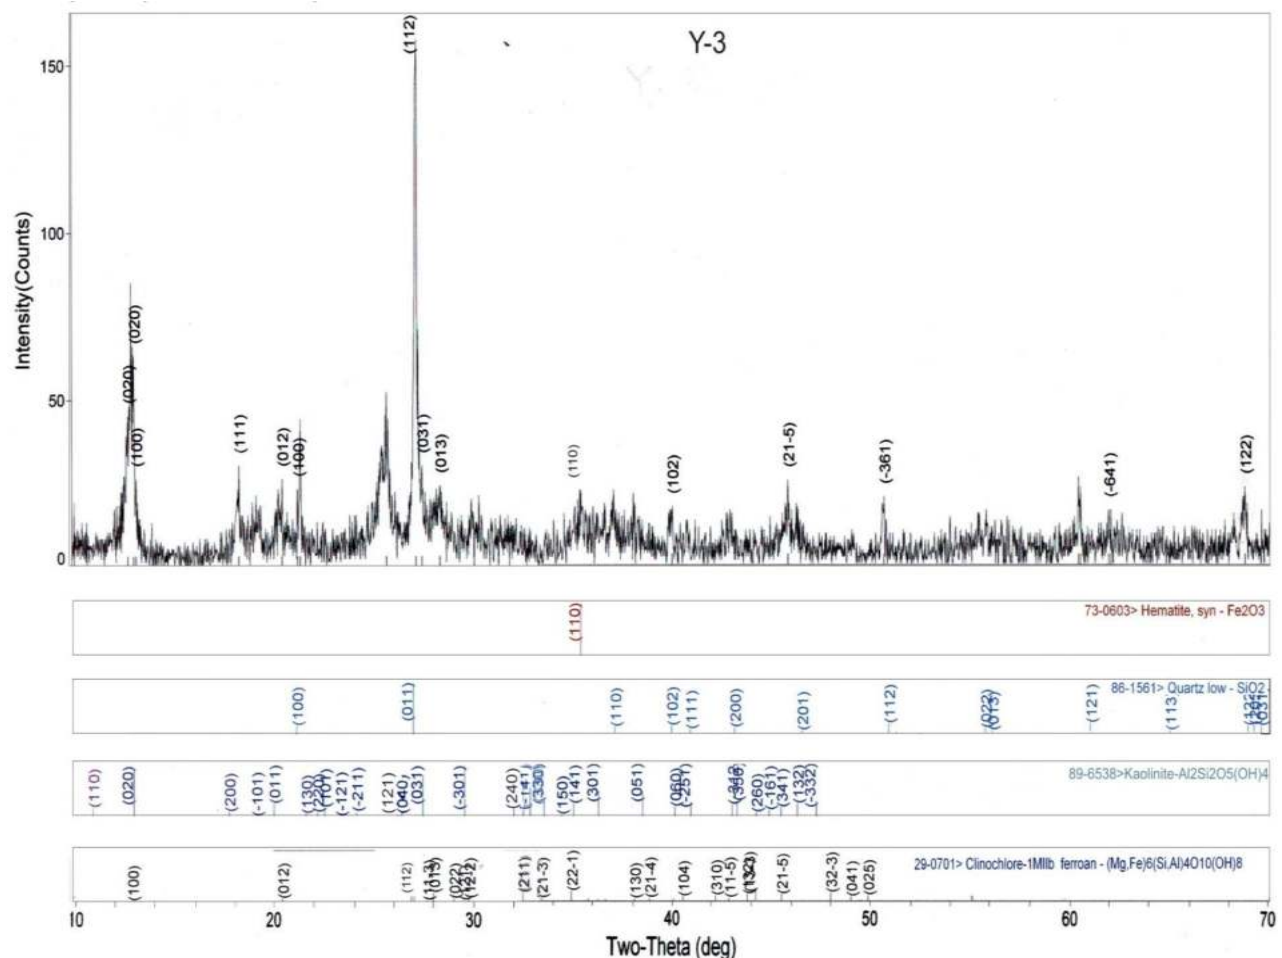
Fig. (13) XRD Spectrum of Y-3

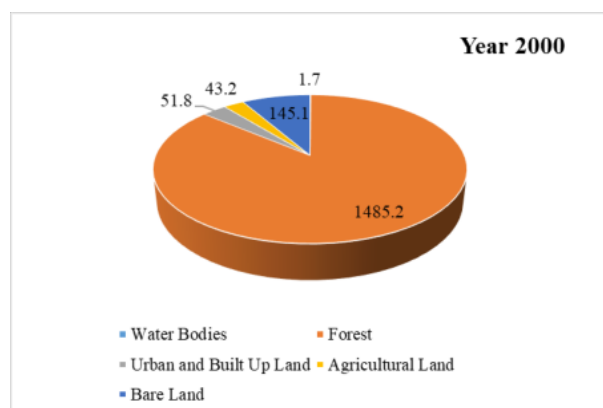
Figure 4. Area amount of Land Use and Land Cover (km²) in Shwegyin River Basin in Year 2000

5. Change in bare land: There was a little change in bare land between 2000 and 2020. The amount of bare land in Shwegyin River Basin was 145.1 km², accounting for 8.4% of the total area in 2000. In the period of 2020, the amount of bare land was fallen down and was 126.9 km² (7.3% of total area). Therefore, it was found that the amount of bare land in 2020 declined 1.1% of that in 2000.

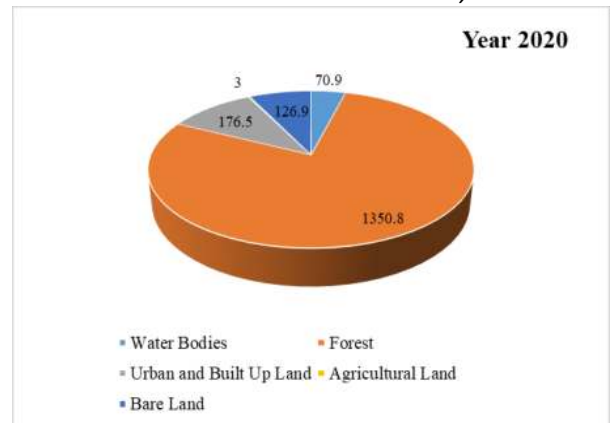
Figure 5. Area amount of Land Use/Land Cover (km²) in Shwegyin River Basin in Year 2020
